Task 1 Report – Literature Review

Exploration of UHPC Applications for Montana Bridges

Civil Engineering Department
College of Engineering
Montana State University – Bozeman

Prepared for the
MONTANA DEPARTMENT OF TRANSPORTATION
in cooperation with the
U.S. DEPARTMENT OF TRANSPORTATION
FEDERAL HIGHWAY ADMINISTRATION

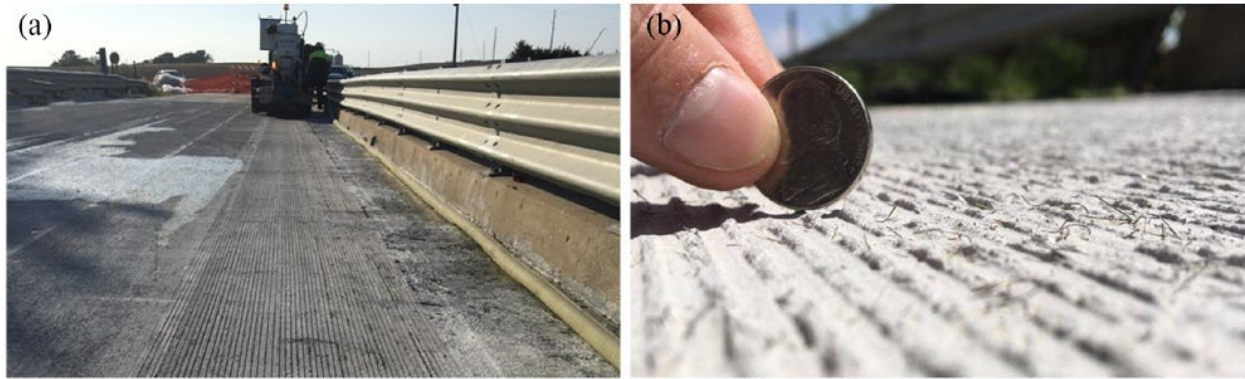
Figure 3: UHPC overlay on Mud Creek Bridge deck: (a) grooving of the surface; (b) closeup of finished surface [23]

to mix 0.65 yd³ (17.55 ft³) of material. Loading and batching of the UHPC took approximately 20 minutes per batch. An overlay thickness of 1.5 in. was compacted and maintained by using a vibratory truss screed. All the mixing was done at one end of the bridge and transported using a mini concrete dumper. Grinding and grooving of the UHPC deck surface took place 4 days after placement (Figure 3), at which point the compressive strength had reached 12.3 ksi. Finally, the deck was evaluated using pull-off tests to quantify the bond strength between the UHPC and the substrate material.

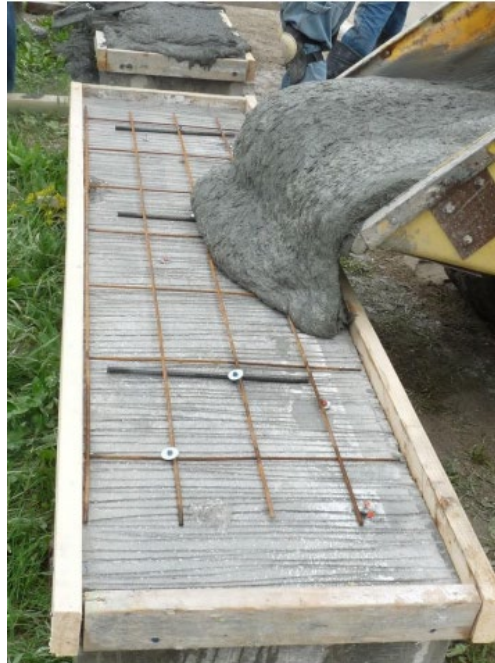
Figure 4: Casting UHPC on slab specimens [23]

Two additional composite slabs with a wire mesh were cast using the UHPC mix from the bridge. This was done as a continuation of the flexure tests described earlier, but was focused on investigating the strength gain from using a wire mesh. The specimens were prepared similar to the negative moment sections of the bridge, though had to have the surface manually grinded instead of mechanically grooved like the bridge, due to the specimen size. The slabs being prepared are shown in Figure 4. The slabs were tested with a positive and negative moment and compared to an NC slab without an overlay. Results showed that both overlay specimens (positive and negative moment) showed increased strength and stiffness compared to the NC slab, though this was in part due to the additional 1.5-in. thickness from the overlay. The researchers concluded that the wire mesh did not add significant strength to the negative moment strength, due to the small amount of reinforcement added. A larger area of steel could lead to increased strengths, although could also affect the bond strength between the two layers. Figure 5 shows (a) the typical load setup used in this testing (similar to Figure 2), (b) the observed shear failure mechanism followed by partial UHPC debonding, and (c) the UHPC layer pried open after the test.

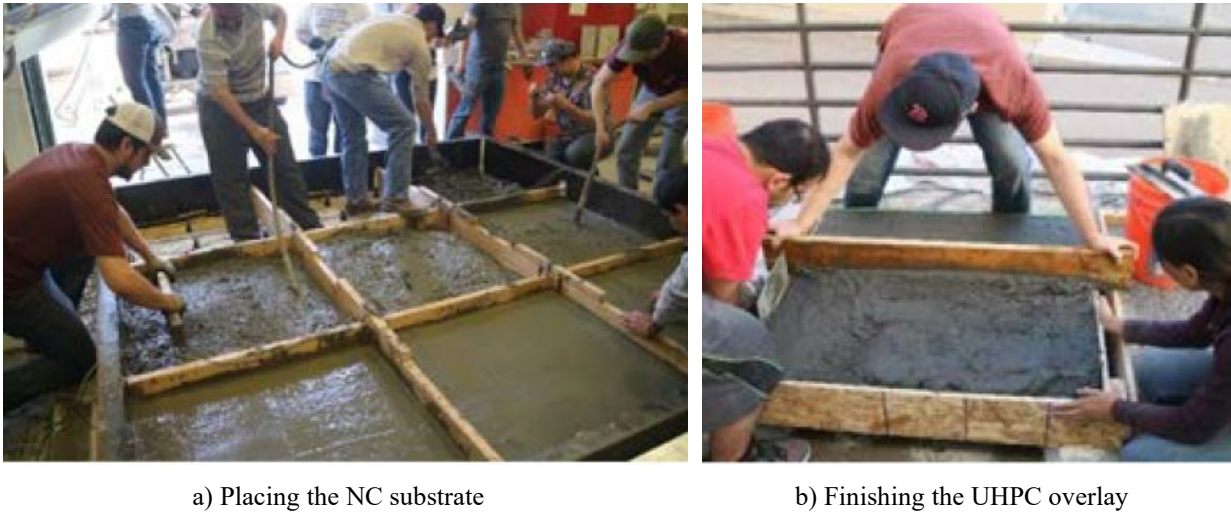
Figure 6: Preparation of UHPC-NC slabs [24]

To test the combined effects on shrinkage of composite UHPC-NC slabs, seven composite slabs were made with varying thicknesses of NC, exposure condition, steel reinforcement, and application of overlay. The NC slabs were cast first and at day 30 the surfaces were prepared with air hammers and chisels until the aggregates were exposed. Texture depth was measured following ASTM E965 and the average depths ranged from 0.06 in. to 0.15 in. Next, the UHPC overlays were cast and two photographs of the slab preparation are shown in Figure 6. Strains and external temperatures were measured over time. The results showed that the reinforcement of the NC layer had the greatest impact on reducing shrinkage caused by the UHPC overlay. However, NC layer thickness also played a role as thicker substrate slabs experienced more shrinkage than thinner slabs, with the same amount of steel; therefore, reinforcement ratio is key. Comparing the laboratory and outdoor exposure conditions, as expected, more uniform shrinkage was found for the laboratory specimens.

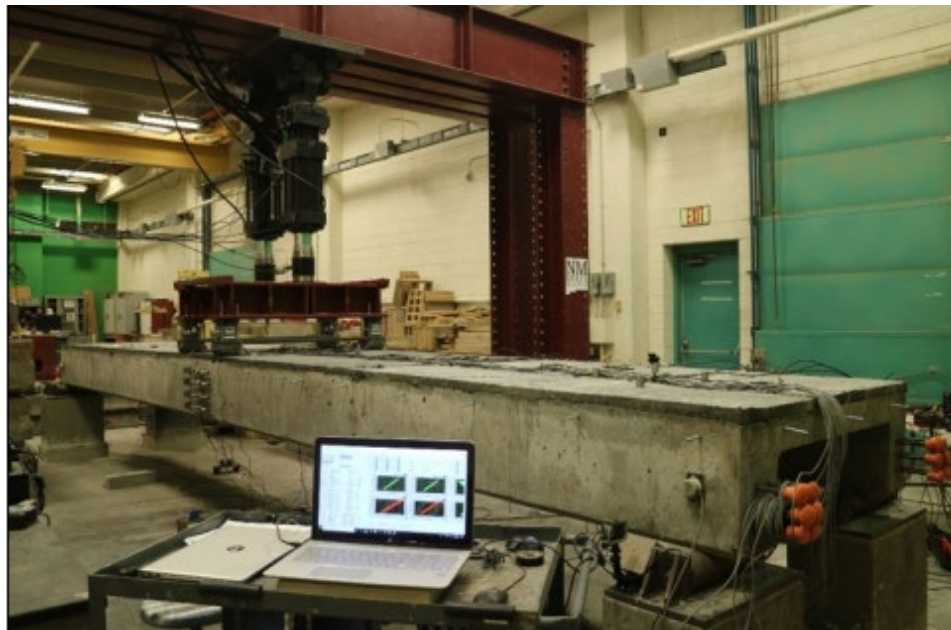
Figure 7: Channel Girder with UHPC overlay [24]

To evaluate the effects of strengthening a beam with UHPC, fatigue tests were first performed on a plain channel girder, which was then overlayed with UHPC as shown in Figure 7. The girder was first fatigue tested through 1,000 load-unload cycles to an approximate mid-span deflection of 0.4 in. and average load of 20.3 kips. After unloading the beam, a residual mid-span deflection 0.0516 in. remained. A 1.0 in. UHPC overlay was then added to the beam and the same loading cycles were repeated. After the addition of the overlay, the girder saw an increase in flexural strength and required an additional 5.45 kips to reach the same deflection. After unloading the beam, a residual mid-span deflection of 0.037 in. remained, though no visual cracking or debonding was observed. The beam was then loaded to failure. Cracking first occurred at a deflection of 0.53 in. and a load of 33.1 kips. The ultimate deflection and load were 5.99 in. and 90.7 kips, respectively. Even at ultimate loading, little to no cracking occurred in the UHPC layer with only isolated locations of delamination.

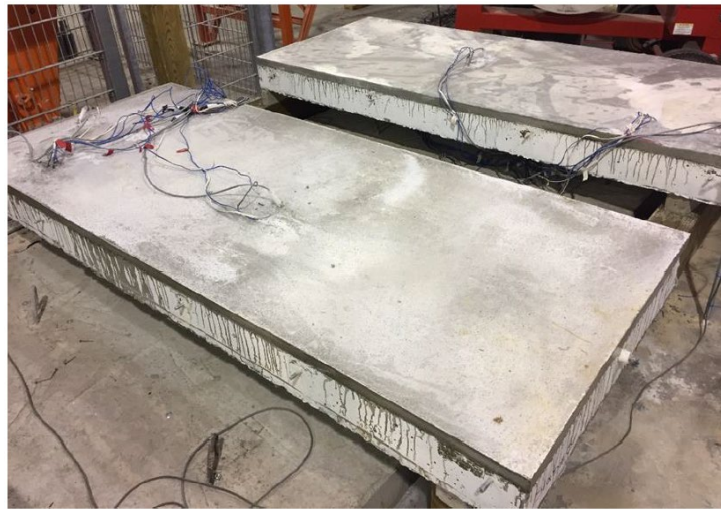
Figure 8: Example NC slabs with UHPC overlay and instrumentation [26]

The Missouri Department of Transportation funded a research project at Missouri S&T on designing an optimized UHPC mix for bridge deck overlays [26]. Sixteen NC slabs were prepared to test different mix designs and thicknesses and compare to latex modified concrete (LMC). The slabs contained rebar mats near the top and bottom of the slab. The top surface was prepared using a chemical surface retarder and a stiff brush to expose the aggregate. The slabs were then left outside for 12 months prior to applying the overlay. Strain gauges, relative humidity sensors, and thermocouples were embedded between NC and UHPC layers (Figure 8). A life cycle cost analysis was also performed to compare UHPC and NC. The results showed that a 1.0 in. UHPC overlay was the most cost-effective based on deterministic and probabilistic results. Additionally, the cost of UHPC is likely to decrease as demand and production increases, making it more desirable as an overlay material in the future.
